## TECHNICAL TIP - CMNXT (TMK) TRAVELLING INVERTERS

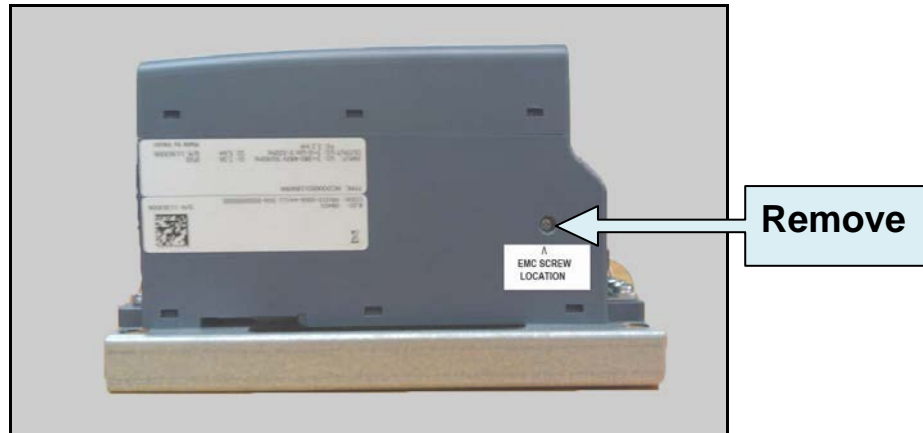
- **An under or over voltage fault** may occur at start-up in crane packages utilizing the newest CMNXT (aka TMK) travelling inverters.
- If this fault occurs, remove the EMC screw located on the left side of the CMNXT inverter and see if the fault is eliminated.

Code	Fault	Possible Cause	Solution
2	Power supply under- or over voltage, over voltage at start	<ul style="list-style-type: none"> <li>• The supply voltage is below 240VAC.</li> <li>• The supply voltage is unbalanced.</li> <li>• The deceleration time is too short.</li> <li>• The supply voltage is over 528 VAC (480V+10%), has over voltage spikes or not sinusoidal wave form.</li> </ul>	<ul style="list-style-type: none"> <li>• Check that the supply voltage is not unbalanced.</li> <li>• Check that the supply voltage level is above 380VAC-15%. Use, for example, an autotransformer to boost the voltage.</li> <li>• Set a longer deceleration time.</li> <li>• Measure the supply voltage level and wave form, use an autotransformer to lower the voltage.</li> <li>• Check the braking resistor cable (model 006, not 003).</li> <li>• Check the braking resistor type and resistance (internal 120_, external 90_).</li> </ul> <p><b>To reset:</b> Voltage must increase above the limit OR power off and restart after 1 min. Main voltage must be under 528 VAC</p>
