TECHNICAL TIP - CMNXT (TMK) TRAVELLING INVERTERS

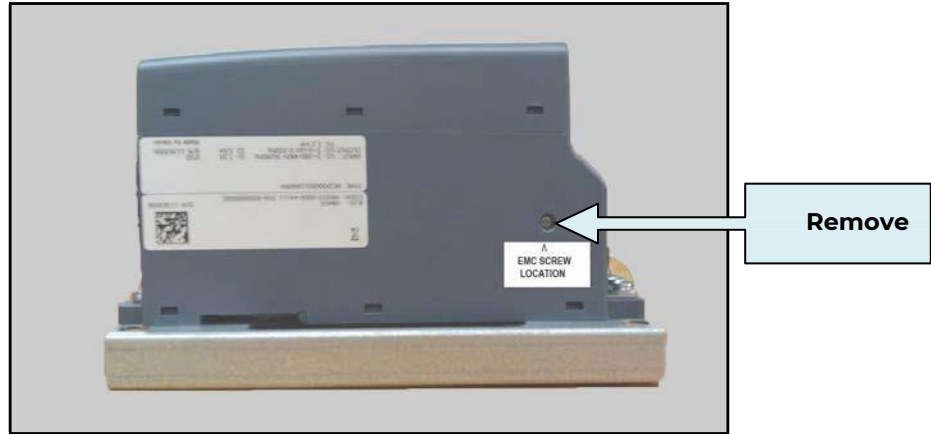
- **An under or over voltage fault** may occur at start-up in crane packages utilizing the newest CMNXT (aka TMK) travelling inverters.
- If this fault occurs, remove the EMC screw located on the left side of the CMNXT inverter and see if the fault is eliminated.

Code	Fault	Possible Cause	Solution
2	Power supply under- or over voltage, over voltage at start	<ul style="list-style-type: none"> • The supply voltage is below 240VAC. • The supply voltage is unbalanced. • The deceleration time is too short. • The supply voltage is over 528 VAC (480V+10%), has over voltage spikes or not sinusoidal wave form. 	<ul style="list-style-type: none"> • Check that the supply voltage is not unbalanced. • Check that the supply voltage level is above 380VAC-15%. Use, for example, an autotransformer to boost the voltage. • Set a longer deceleration time. • Measure the supply voltage level and wave form, use an autotransformer to lower the voltage. • Check the braking resistor cable (model 006, not 003). • Check the braking resistor type and resistance (internal 120_, external 90_). <p>To reset: Voltage must increase above the limit OR power off and restart after 1 min. Main voltage must be under 528 VAC</p>
