TECHNICAL TIP - "M" SERIES BRAKES

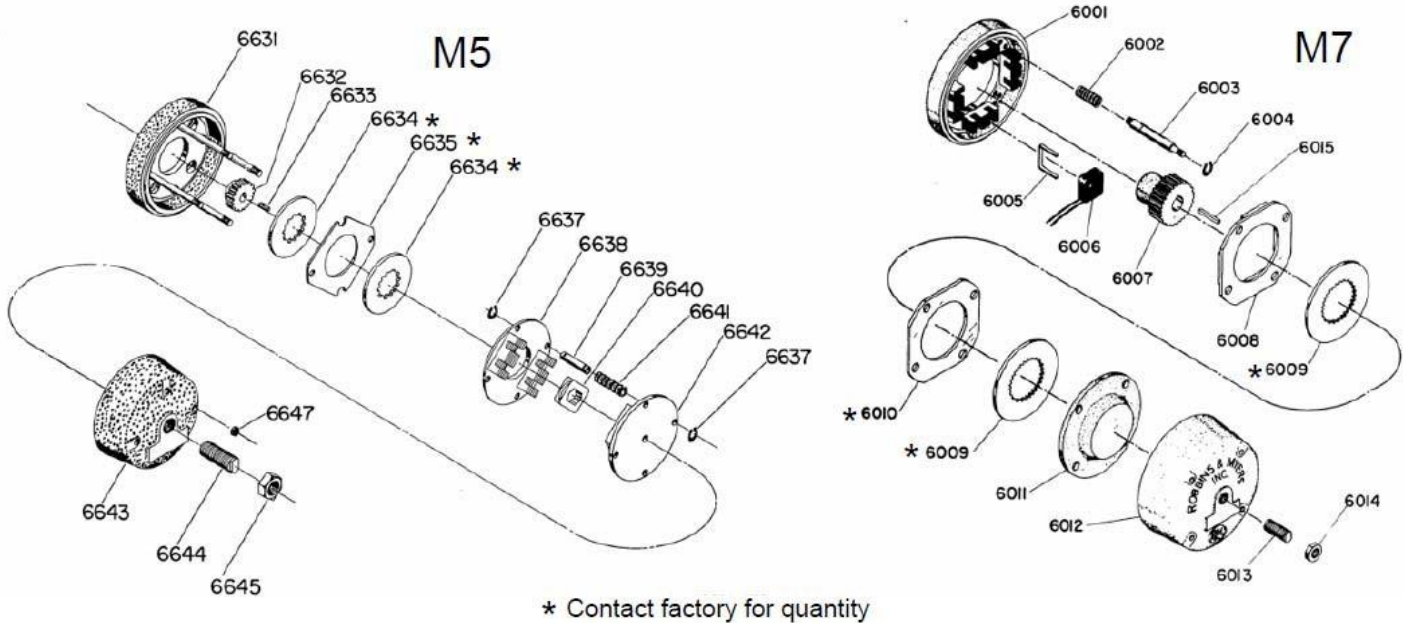
- 1) The "M" series brakes may be wired in a 'series' configuration or a 'series-parallel' configuration based on the number of brake coils in a particular brake. When there are two brake coils they must be wired in 'series' so the "E" and "I" frames pull together evenly. If line voltage coils are used and wired in 'parallel' the brake coil that receives the voltage first will try to pull in ahead of the other coil, causing the "E" frame (6639) to jam against the brake studs (6003). This jamming will prematurely wear the brake studs, intermediate plates, coil mounting plates, and ultimately damage the brake beyond repair. When installing new brake coils make sure there is no varnish on the coil electrical connections that can create an electrical insulator. Use new flag terminals to insure a good electrical connection. Proper wiring connections may be found on our website at:
